# Guía operacional para **INSTALACIONES ECOTURÍSTICAS Y TURISMO SOSTENIBLE**

COMPAÑÍA DE  
**TURISMO**  
PUERTO RICO

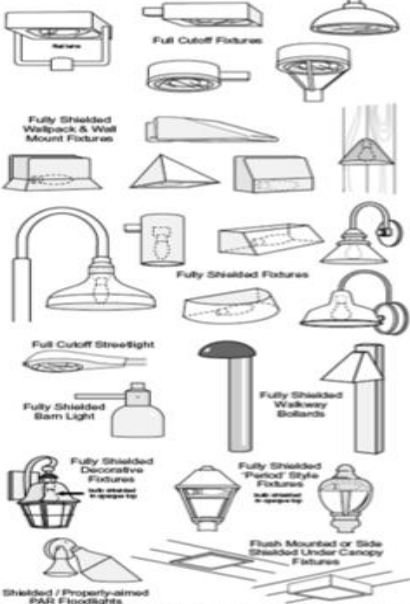
REFERENCE
63		OUTDOOR LIGHTING								
64		<div><p><b>Acceptable</b> Fixtures that shield the light source to minimize glare and light trespass and to facilitate better vision at night</p>

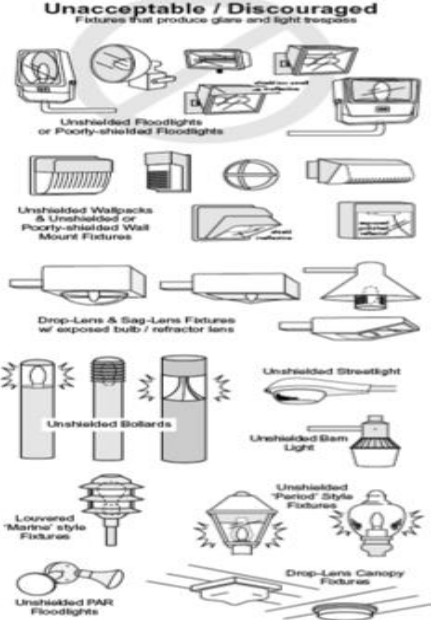
REFERENCE
65		<p><b>Unacceptable / Discouraged</b>  Fixtures that produce glare and light trespass</p>
